Re: December 2011 Monthly Progress Report
Administrative Settlement Agreement and Order on Consent for Removal Action
U.S. EPA Region 10 Docket No. CERCLA 10-2009-0255
Gasco Sediments Site within the Portland Harbor Superfund Site

Visual Observations Log Form

Monitoring Period: Monthly (Year 5)—December 2011

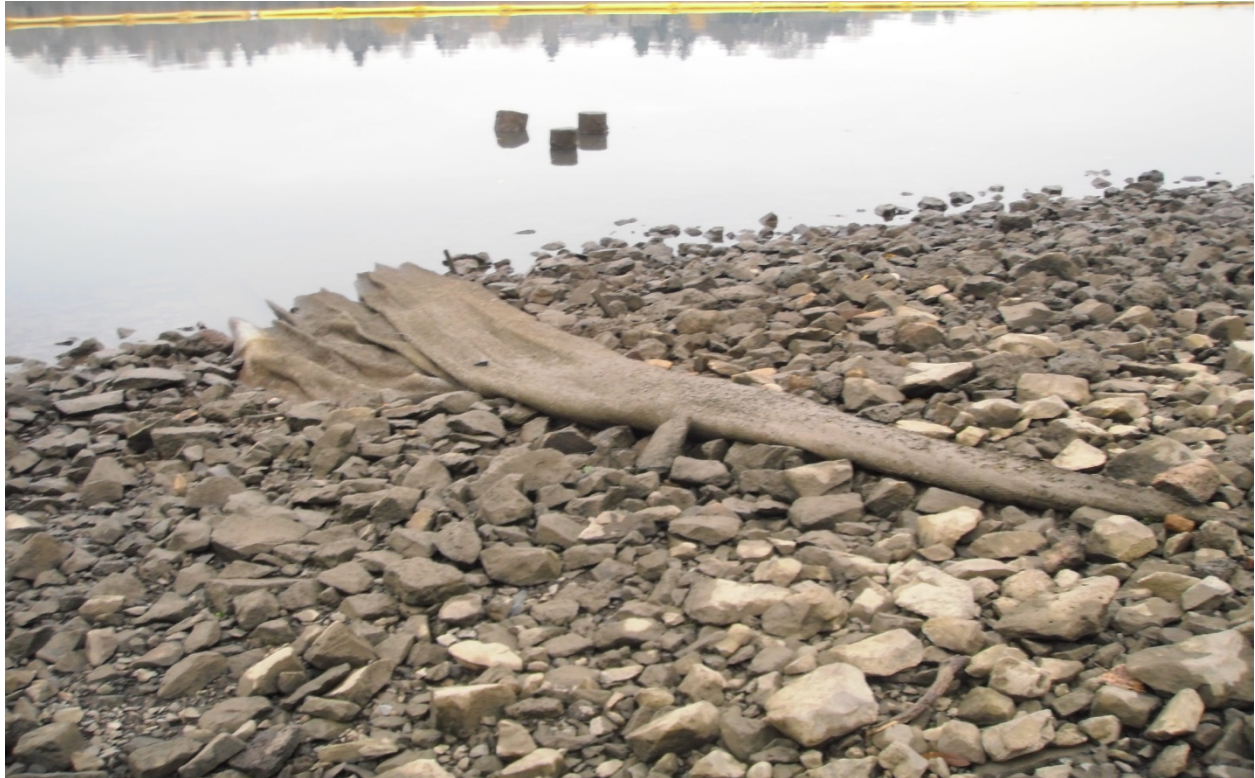
Observations of Erosion/Deposition: No erosion/deposition is evident along the shoreline. Four organoclay mat material segments are exposed and visible. One section of organoclay mat is 20 feet in length and is visible at the upriver extent of the cap area (Photo 1). Near the midpoint of the cap area shoreline, two segments 4-foot and 2-foot in width are exposed approximately 8 feet from the water's edge. A 30-foot section of mat material is exposed near the downriver extent of the cap.

Photo 1—*exposed section of organoclay mat, perpendicular to the shoreline near the upriver extent of cap area (12/14/11):*

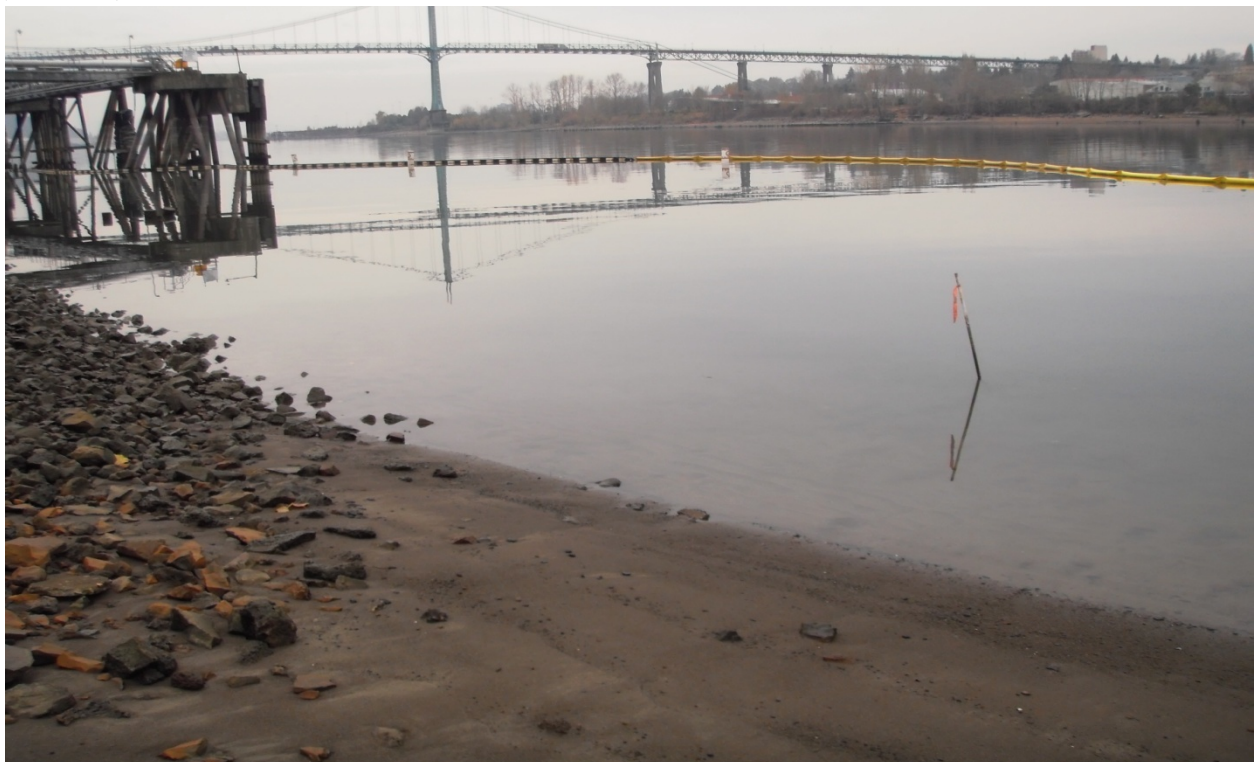
Observations of Long-term Controls (i.e., oil booms, organo-clay mat, etc.) During the observation, the Fuel and Marine Marketing (FAMM) containment boom was placed across the cap area, between the upriver corner of the ship dock and the wooden dolphin (near the upriver extent of the site and near the Siltronic Corporation outfall. Buoys that identify the cap area to mariners are in place as installed. The position of the FAMM oil boom, warning buoys, and a general overview of the site shoreline is shown in Photo 2.

Photo 2 — *FAMM oil boom shown and mariner warning buoys in place across pilot cap area. (12/14/11):*

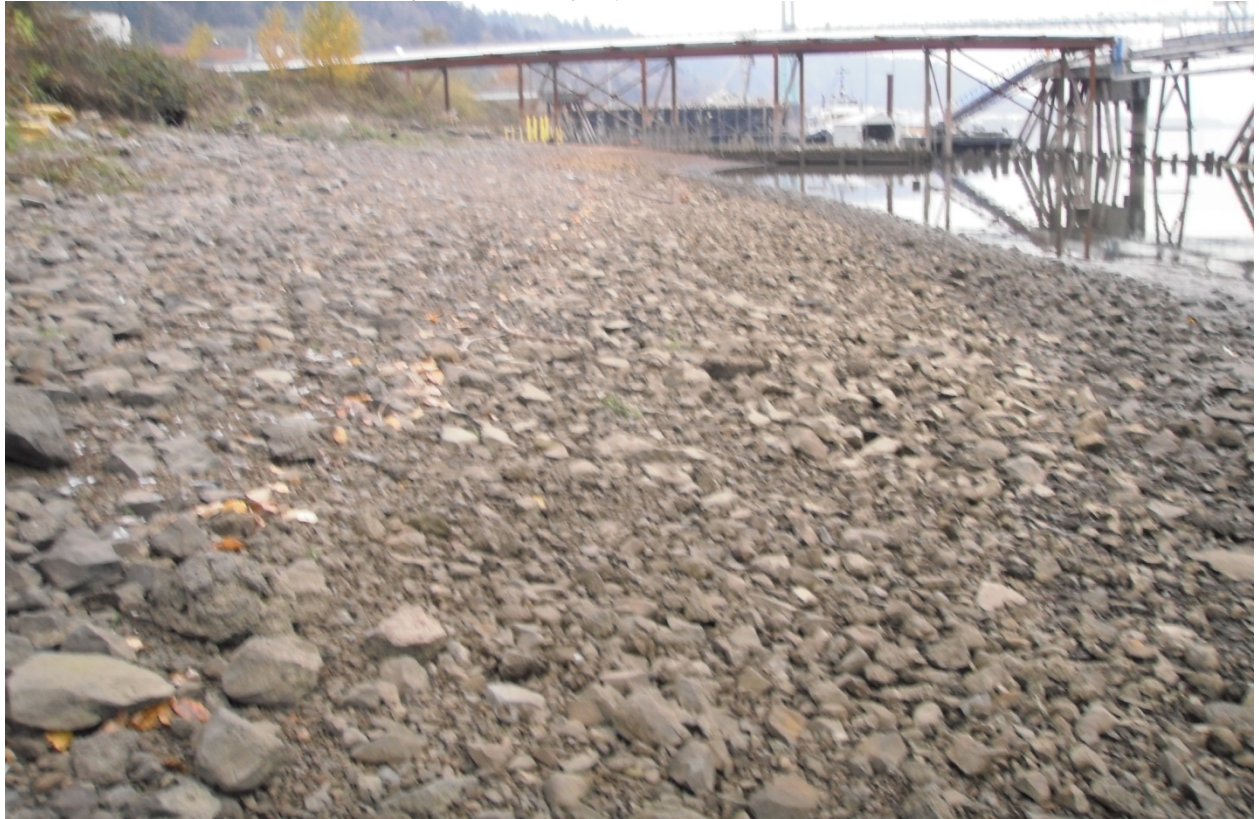
Other Comments: No sheen is evident in or around the cap area. Photo 3 shows the water surface and shoreline immediately downriver of the sediment cap.

Photo 3 — *Conditions immediately downriver of cap area (12/14/11):*
